Ardmore Area Subwatershed Stormwater Retrofit Assessment

Hennepin County
Public Works
Environment and Energy

Prepared by Hakanson Anderson and Hennepin County Department of Environment and Energy with assistance from the Metro Conservation Districts

March 2016

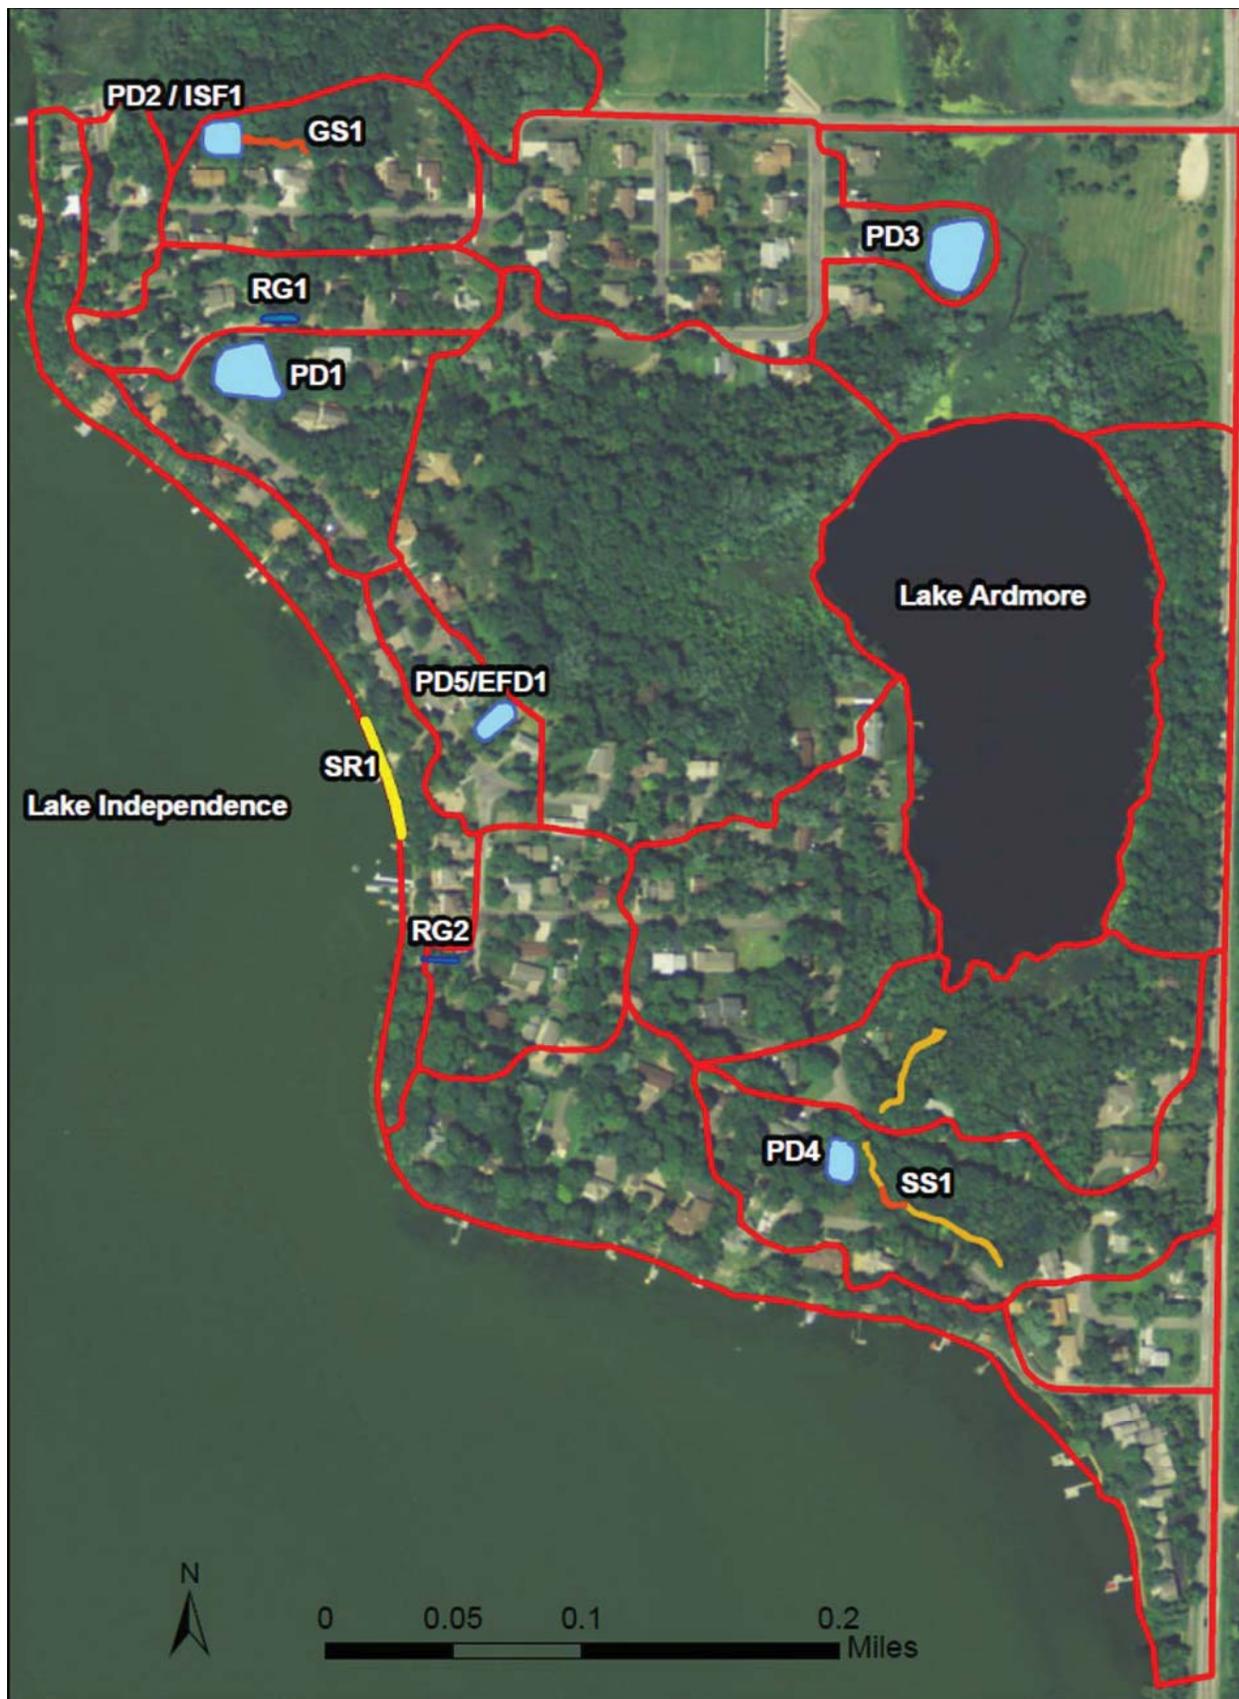
Figure 1U: Proposed BMP exhibit within drainage areas

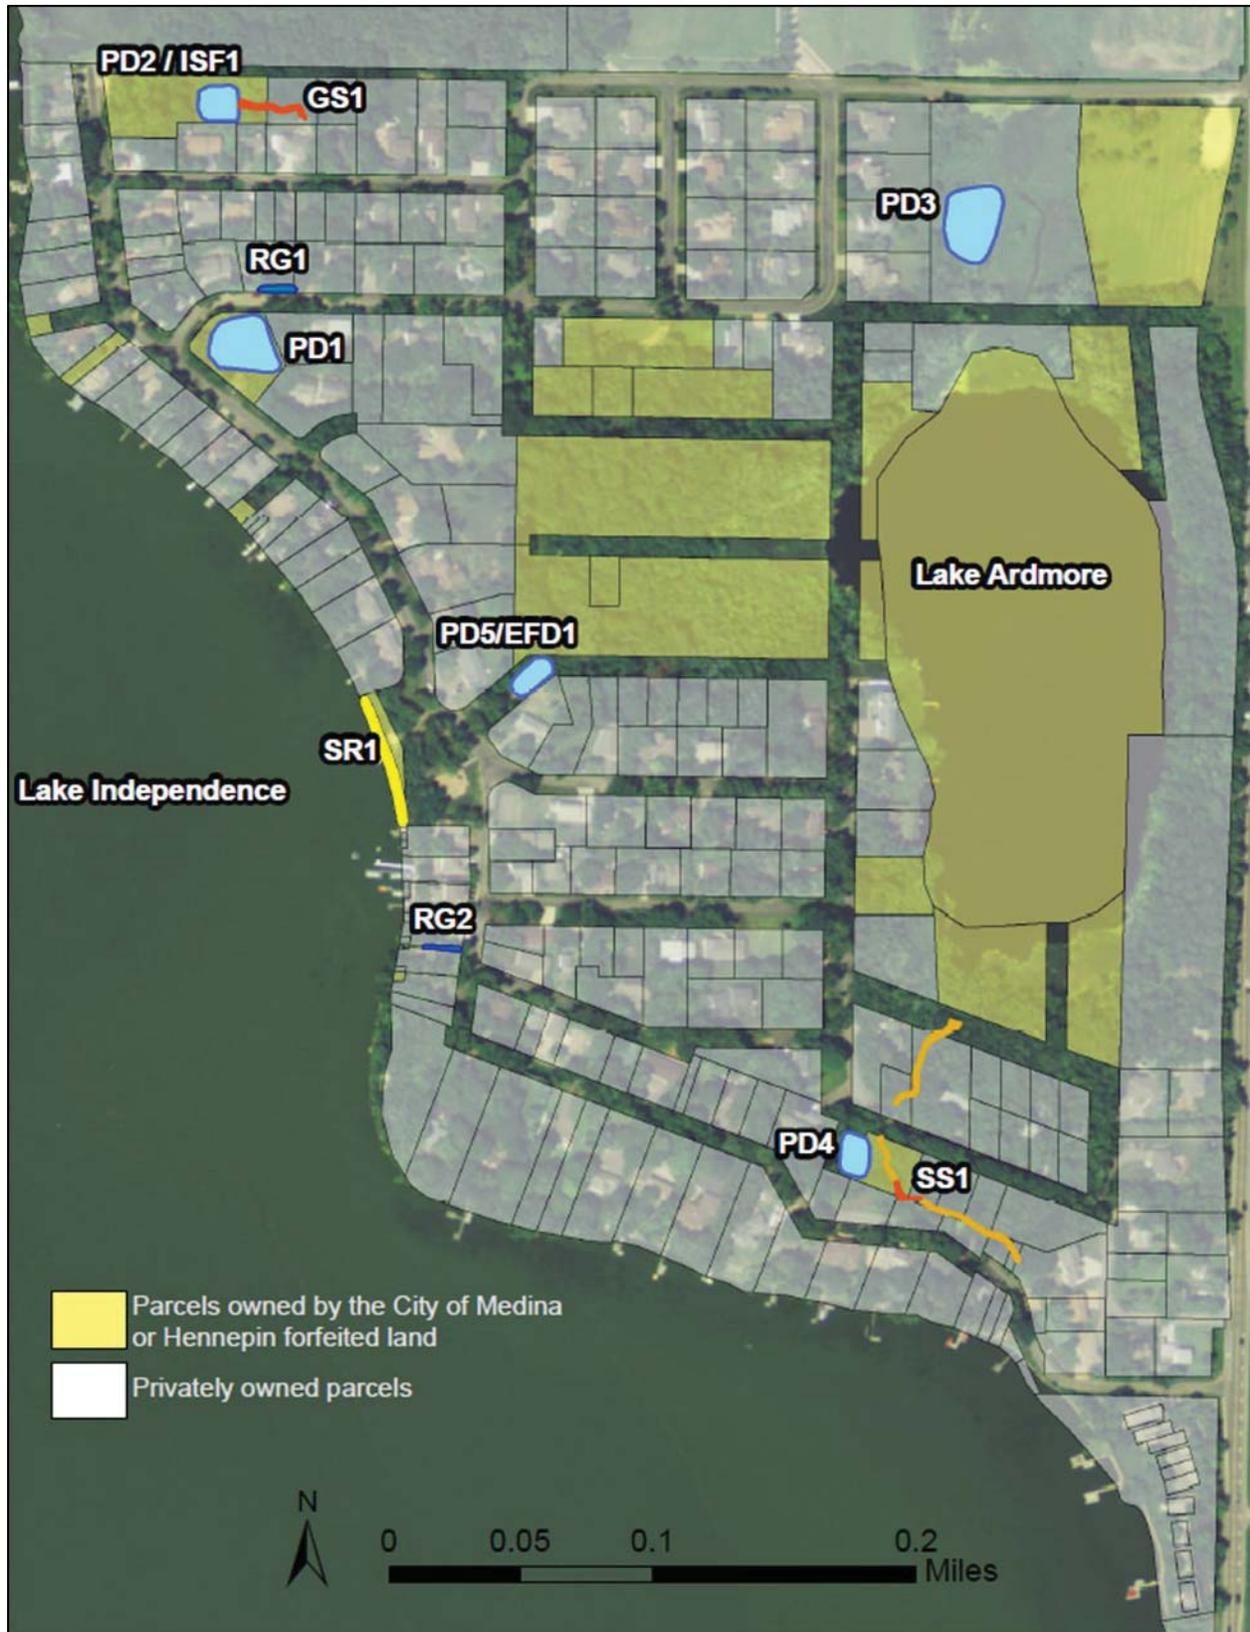
Figure 2U: Proposed BMP exhibit within parcels

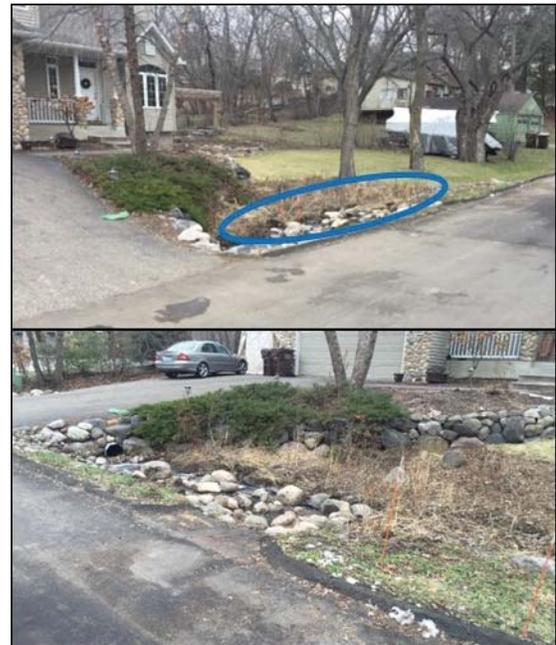
Figure 4U: Site photographs at proposed RG1

Two rain garden projects were chosen for this analysis. The first rain garden (RG1) is located on Walnut Street across from Walnut Park. It appears that a rain garden may have been previously attempted for this site; however, it does not appear to be functioning well and enhancements are proposed. There is an existing curb cut leading directly to the rain garden site, which can be seen in **Figure 4U**. In order to be effective, the rain garden must be over-excavated, filled with engineered media, and an underdrain installed. The final surface of the rain garden must be approximately 1.5’ below the adjacent culvert to provide ponding during rain events. The phosphorus removal rate was estimated using the MIDS calculator. The projected phosphorus removal for RG1 is 1.1 lbs per year.

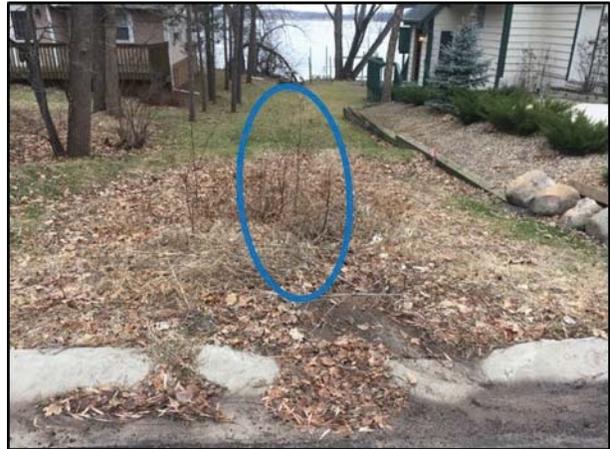
The second proposed rain garden (RG2) is on Lakeshore Avenue across from Brooke Street. There is already a rain garden on the east side of Lakeshore Avenue, but on the west side, the water is directed towards a curb cut that leads straight to Lake Independence (**Figure 6U**). A rain garden at this location could filter the runoff and decrease the phosphorus load before it enters the lake. The existing storm sewer pipe would be modified, with the rain garden intercepting and filtering the stormwater runoff. Suspended solids and particulate phosphorous would be trapped in the rain garden basin.

Figure 6U: Looking west to Lake Independence. The blue circle shows proposed location for RG2.

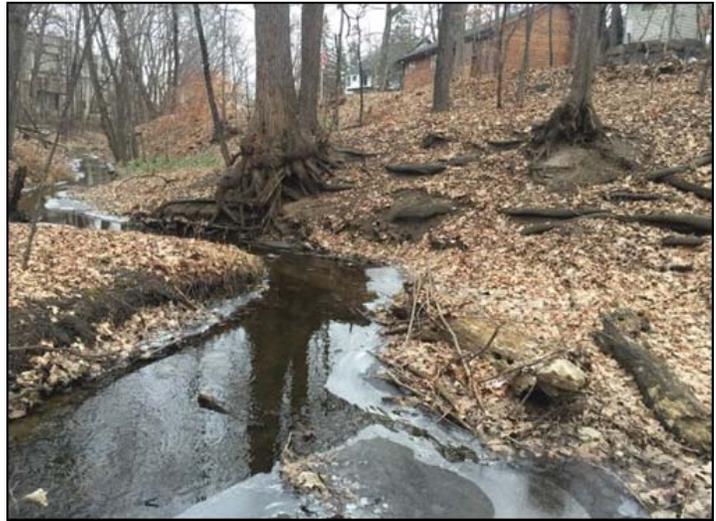
We measured the volume of the moderate erosion to be approximately 40 cubic feet. The BWSR Pollution Reduction Estimator estimated 0.2 lbs/yr of phosphorus export from this area. Repairing the stream bank erosion would cease its TP loading. Repair and stabilization of this area may be accomplished by placement of toe boulders, brush bundles, or geo-synthetic mats. Native vegetation with deep root systems also helps stabilize these areas but may be difficult to establish in this location due to the extensive tree cover.

Figure 8U: Erosion seen looking southeast

Although the remaining portions of the channel are un-vegetated and may be susceptible to erosion, BMPs are not proposed at this time. Active erosion was not observed during field reconnaissance, and similar to the area above, stabilization by establishing a vegetated stream bottom would be extremely difficult due to the extensive tree cover. If observations at a later date determine stream bed erosion to be a concern, this segment should be re-evaluated.

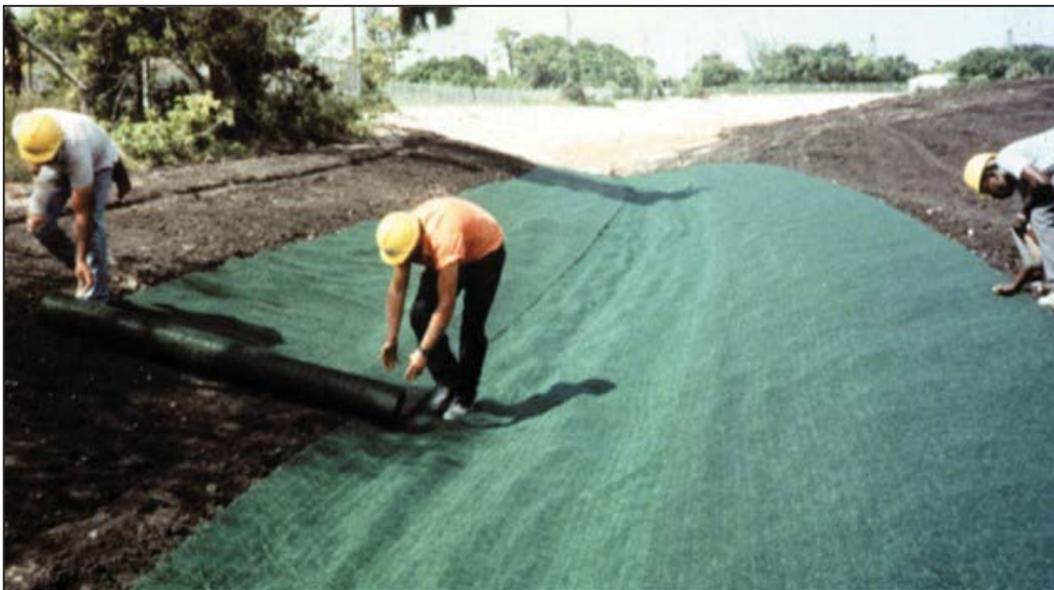
Gullies are created by concentrated stormwater cutting into the landscape and eroding away the soil. This occurs when the erosive force of the water flow is greater than the cohesive force of the soil. Over time the gully cuts deeper into the soil, creating unstable side slopes. The near vertical side slopes of the gully then slough in and are transported downstream into the receiving water. Since particulate phosphorous is attached to the sediment, this directly contributes to the phosphorous loading into the receiving water. If not repaired, gullies continue to cut and become larger and contribute to the phosphorous load.

Figure 10U: Stabilization using manufactured synthetic products; Source: Contech Engineered Solutions

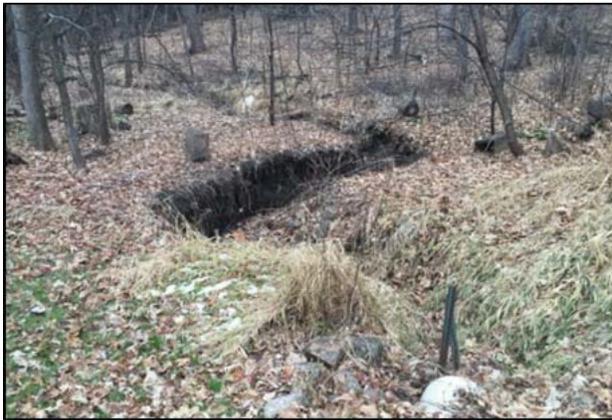
The gully north of Fern Street receives concentrated flow via a storm sewer pipe. Field measurements showed that the gully is approximately 120 feet long. The largest width measurement was recorded as five-feet, and the largest depth measurement was recorded as four-feet. In total, it is estimated that 1,390 cubic feet or 50 tons of sediment has been eroded to date. The BWSR Pollution Reduction Estimator worksheet was utilized to estimate the phosphorous load that the gully is producing. Stabilizing the gully could reduce the TP load by 100%.

Figure 11U: Left— Erosion to the eastern side of the gully. Right - West side of the gully, eventually flowing into wetland connected to Lake Independence.

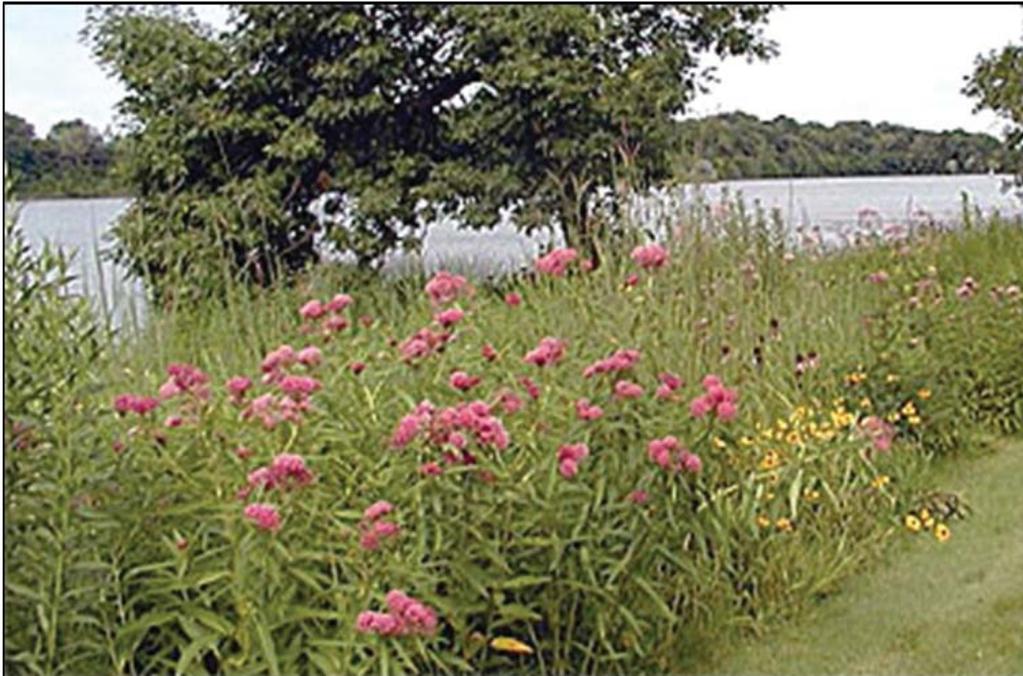
Shoreline erosion is also a source of phosphorus. All of the sediment created by shoreline erosion is directly deposited into the lake with no chance for treatment. Visual observations revealed that shoreline erosion is occurring near Lakeshore Park on either side of the boat ramp. The erosion is approximately 160 ft. long and is estimated to contribute 2 lbs/yr of phosphorus to Lake Independence. This phosphorus load could be greatly reduced by stopping the erosion and restoring the shoreline.

Figure 13U: Photo of shoreline stabilization; Source: MN DNR

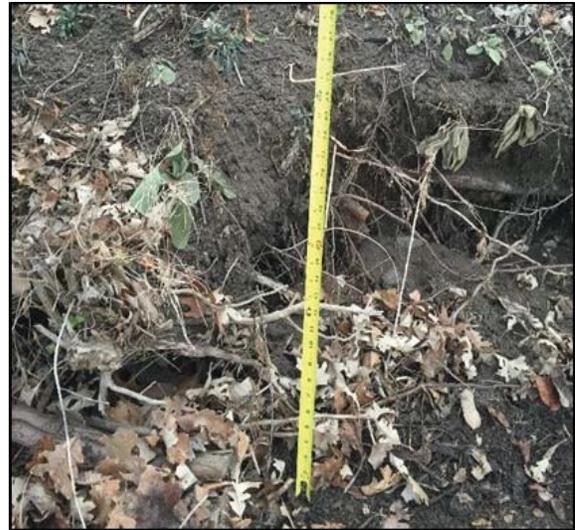
Figure 14U: Close up of the shoreline erosion

Table 8U. Site Summary - SR1	
Model Used	BWSR worksheet
Eroding Shoreline	160 ft
Estimated TP Removal	2.0 lbs/yr
Installation Cost	\$16,000
Design/Admin	\$1,500
Maintenance Cost / yr	\$240
Total 20 Year Cost	\$22,000
\$/lb-TP removal /yr	\$550

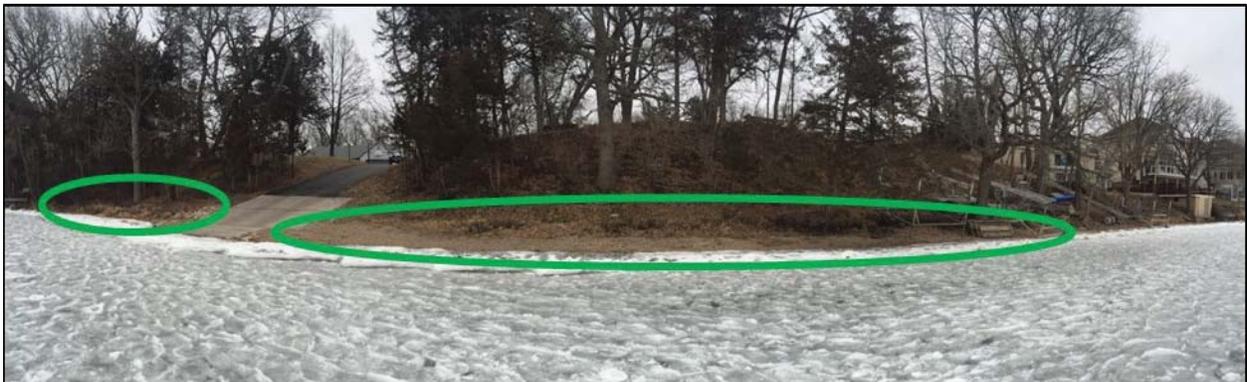
Figure 15U: The erosion exists on both sides of the boat launch. It extends approximately 120 ft. to the right of the launch and 40 ft. to the left.

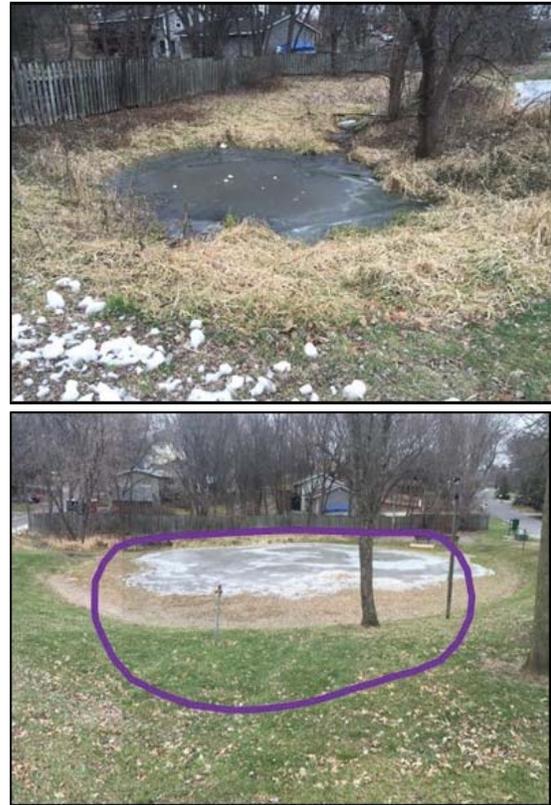
The first proposed pond to be excavated (PD1) is an already existing pond in Walnut Park. The current pond is estimated to have a surface area of 620 square feet and has a drainage area of 2.9 acres. This pond is severely undersized and is providing little treatment in the existing condition. To meet NURP standards, the pond must be enlarged considerably. It is noted that a rain garden is also proposed within this sub-watershed, which would remove a fraction of the suspended solids before entering the pond. Routing stormwater through multiple BMPs is often referred to as a treatment train and can have increased water quality benefits. The phosphorous reduction reported in **Table 9U** takes into account the minimal treatment that is occurring in the existing condition in the undersized pond.

Figure 18U: Top– The existing pond. Bottom– The purple line shows location of proposed pond.

Table 9U. Site Summary – PD1	
Model Used	MIDS
Drainage Area	6.2 ac
Existing Pond Area	620 sq ft
Proposed Pond Area	9,445 sq ft
Estimated TP removal	1.8 lbs/yr
Installation Cost	\$56,600
Design/Admin	\$12,500
Maintenance Cost	\$250
Total 30 Year Cost	\$76,350
\$/lb-TP removal /yr	\$1,414

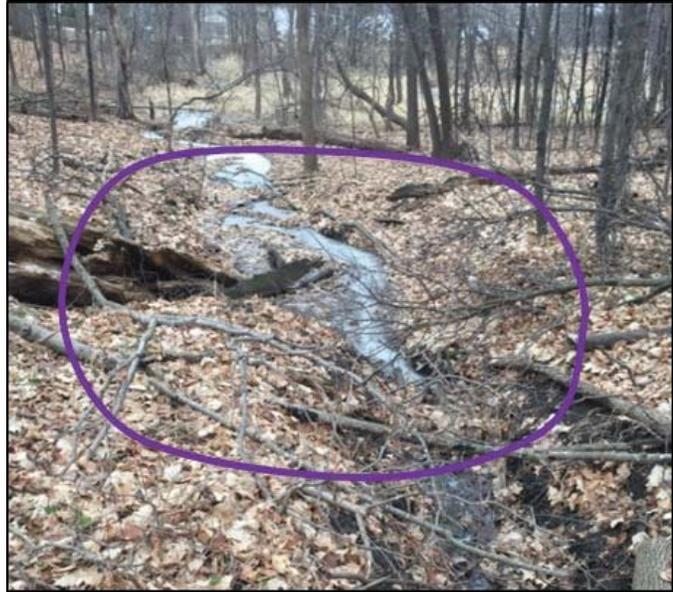
The second proposed pond (PD2) would be located at the receiving end of the eroding gully, north of Fern Street. This is a new proposed pond that would be approximately 2,900 square feet in surface area. This pond would have water quality benefits as it would intercept particulate phosphorous prior to discharging into the large downstream wetland, which is directly connected to Lake Independence. It should be noted that a gully stabilization project is proposed upstream of PD2, and it would be critical that the gully stabilization project be completed prior to implementing PD2.

Figure 20U: Purple outline below shows proposed location of PD2.

Table 10U. Site Summary – PD2	
Model Used	MIDS
Drainage Area	4.1 ac
Proposed Pond Area	5,400 sq ft
Estimated TP removal	1.8 lbs/yr
Installation Cost	\$32,400
Design/Admin	\$8,000
Maintenance Cost / yr	\$250
Total 30 Year Cost	\$47,650
\$/lb-TP removal /yr	\$882

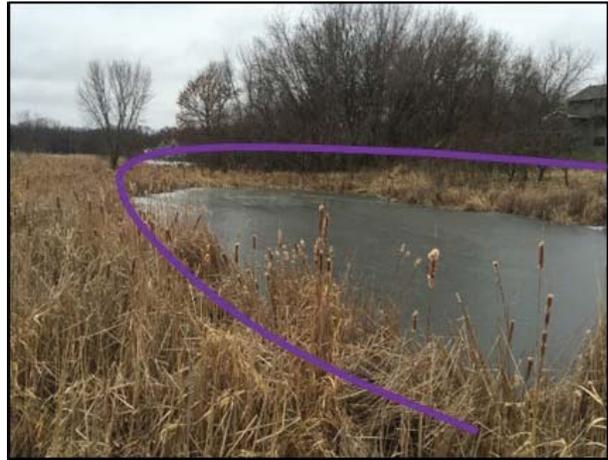
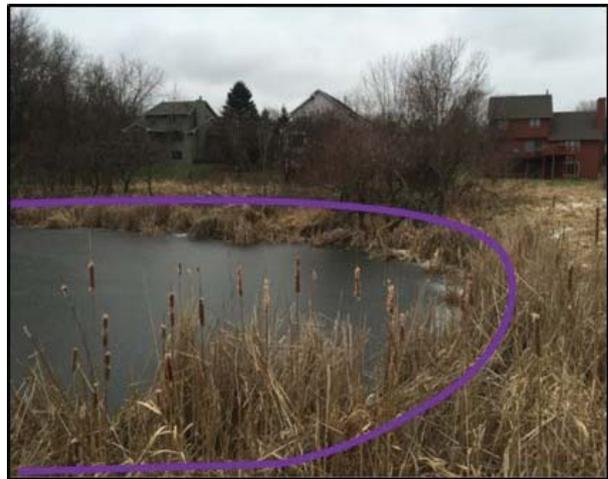
Figure 22U: Purple outline shows proposed enlarged pond for PD3. Above– view looking south. Below– view looking west.

Table 11U. Site Summary – PD3	
Model Used	MIDS
Drainage Area	8.0 ac
Existing Pond Area	8,700 sq ft
Proposed Pond Area	14,000 sq ft
Estimated TP removal	1.1 lbs/yr
Installation Cost	\$31,800
Design/Admin	\$12,500
Maintenance Cost/yr	\$250
Total 30 Year Cost	\$51,550
\$/lb-TP removal /yr	\$1,562

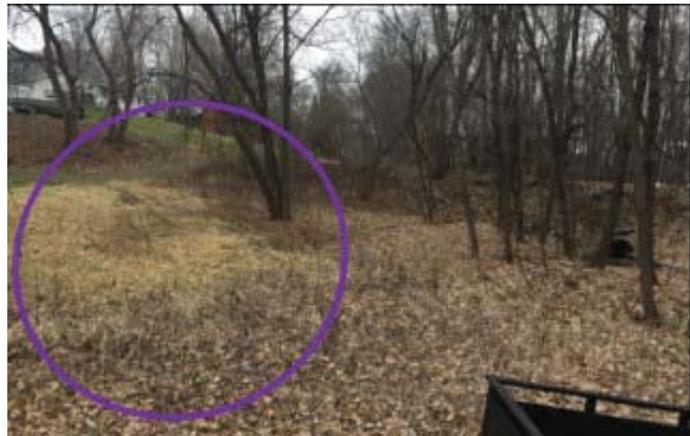
The fourth pond (PD4) would be a new pond west of the stream erosion. In the current condition, the storm sewer from Lakeshore Avenue directs stormwater into the vicinity of the proposed PD4, and it enters the stream untreated. A stormwater pond in this location would treat the stormwater and remove pollutants before discharging it into the stream and ultimately Lake Independence.

Figure 24U: Purple outline shows the proposed location of PD4. View is looking southwest.

Table 12U. Site Summary – PD4	
Model Used	MIDS
Drainage Area	2.7 ac
Proposed Pond Area	4,600 sq ft
Estimated TP removal	1.2 lbs/yr
Installation Cost	\$27,600
Design/Admin	\$12,500
Maintenance Cost/yr	\$250
Total 30 Year Cost	\$47,350
\$/lb-TP removal /yr	\$1,315

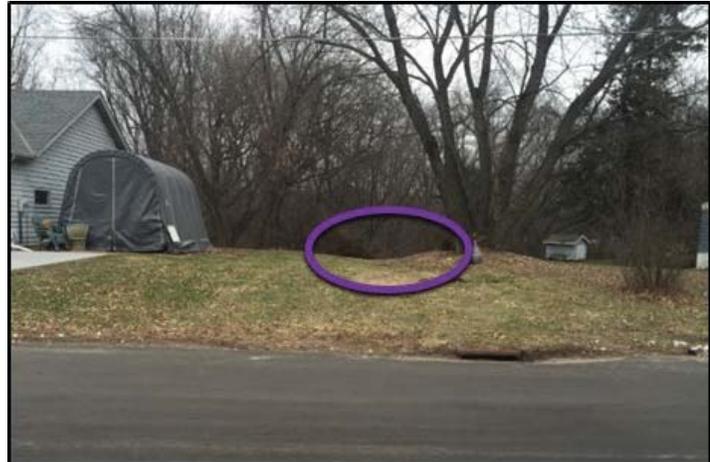
Figure 26U: Purple outline shows location of proposed PD5

Table 13U. Site Summary – PD5	
Model Used	MIDS
Drainage Area	1.6 ac
Proposed Pond Area	4,000 sq ft
Estimated TP removal	1.0 lbs/yr
Installation Cost	\$24,000
Design/Admin	\$12,500
Maintenance Cost/yr	\$250
Total 30 Year Cost	\$43,750
\$/lb-TP removal /yr	\$1,458

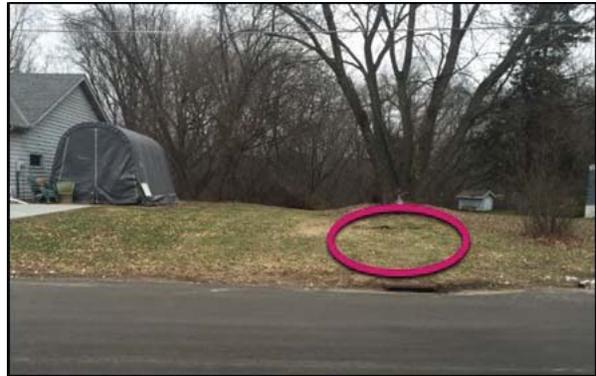
Figure 29U: Possible location of underground enhanced filtering device

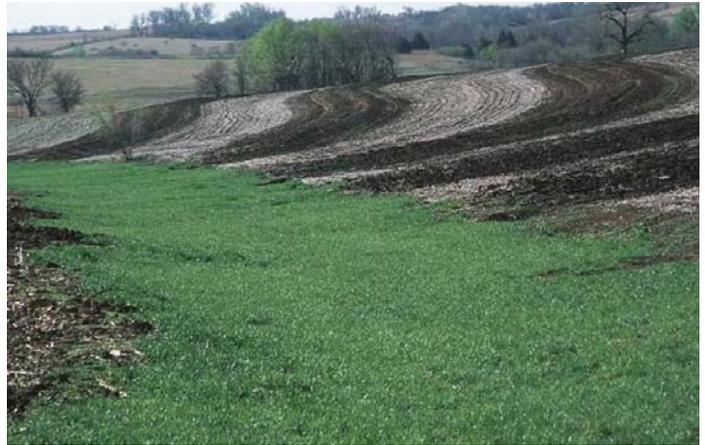
A natural drainage way is graded and shaped to form a smooth, bowl-shaped channel. This area is seeded to sod-forming grasses. Runoff water that flows down the drainage way flows across the grass rather than tearing away soil and forming a larger gully. An outlet is often installed at the base of the drainage way to stabilize the waterway and prevent a new gully from forming.

Figure 6R: Photo of well-functioning grassed waterway

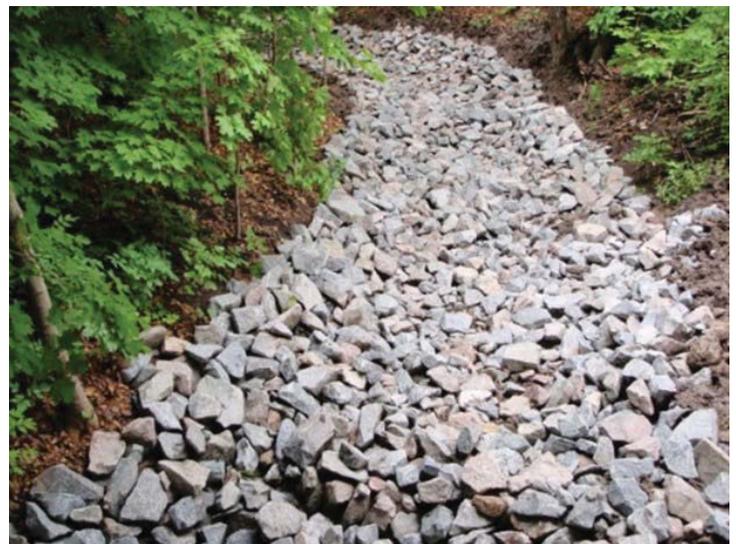
Stabilization of gullies typically requires reducing the volume and the velocity of water flowing through the gully. This can be achieved by refilling the gully and building dikes or small check dams at specific intervals along the gully. Reshaping and stabilizing long and steep banks may also be needed. Typical gully stabilization structures are constructed of rock, gabions or vegetative barriers. Biotechnical methods offer a combination of physical structures along with vegetative.

Figure 9R: Photo of rip-rap lined gully stabilization BMP

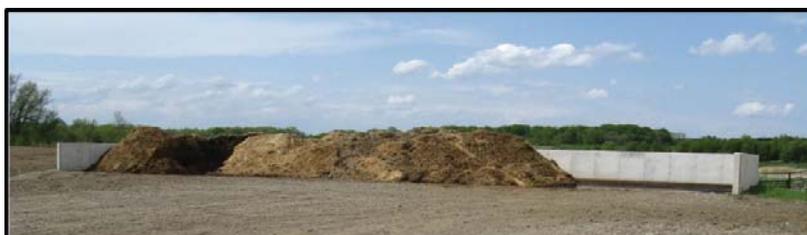
For the two smaller facilities this report used composting as the primary practice to store and dispose of the horse waste and bedding. Livestock site B was designed as a smaller compost storage facility (2 bins 8'x8'x3' for 2 horses). Livestock site C was designed with a larger compost facility (4 bins 8'x8'x3' for 6 horses).

Figure 13R: Photo of aboveground concrete storage system for horse waste
